# **GREEK CATHOLIC WOODEN CHURCHES IN SLOVAKIA**

Assessment of construction and technical condition of the buildings  
and mobiliar

**Prepared by: Ing. Arch. Ivan Gojdic**  
**In co-operation with: Ing. Arch. Dusan Ferianc**  
**Photographs by: Juraj Mueller**

**Faculty of Philosophy and Arts**  
**Trnava University**  
**2009**

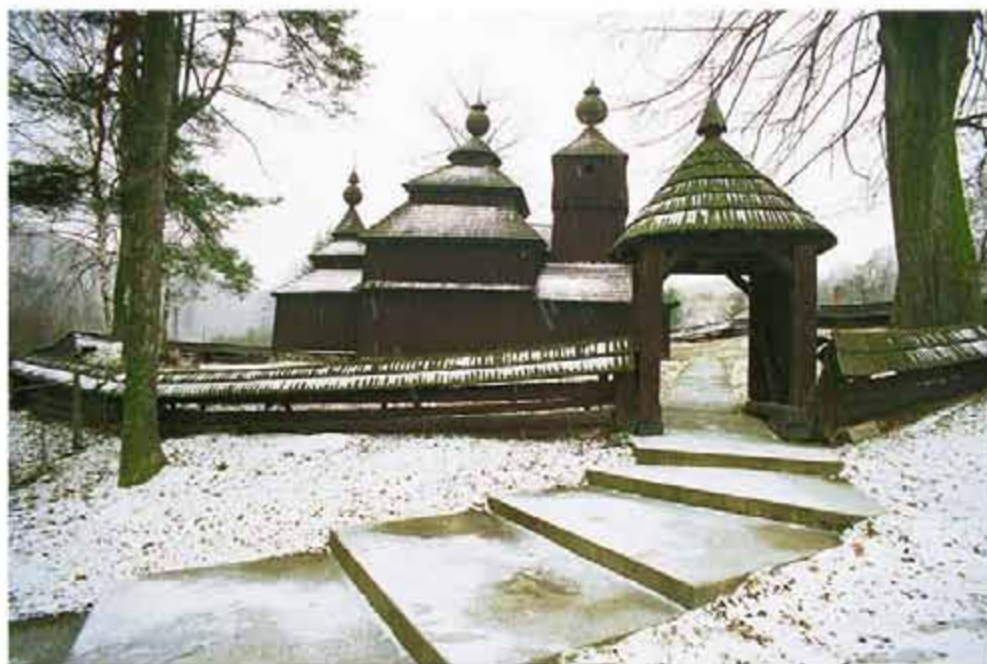
1

Condition: Church covering and shingle roofing are about to root. It is the same for shingle on the fence. There will be some leaks in the short time. Woodworms are active in the log construction and tower and there is a possibility that it can spread to iconostasis and the other mobiliar which is in a good condition at the moment. The last restoration was done in 1990-95.

Suggested measures: Roofing and parts of exterior covering must be replaced. Fence and gate must be renewed. Chemical treatment is needed where there is the presence of woodworm, namely log construction, tower and roof. Signaling gadgets are needed to be checked and lightning must be of better quality.

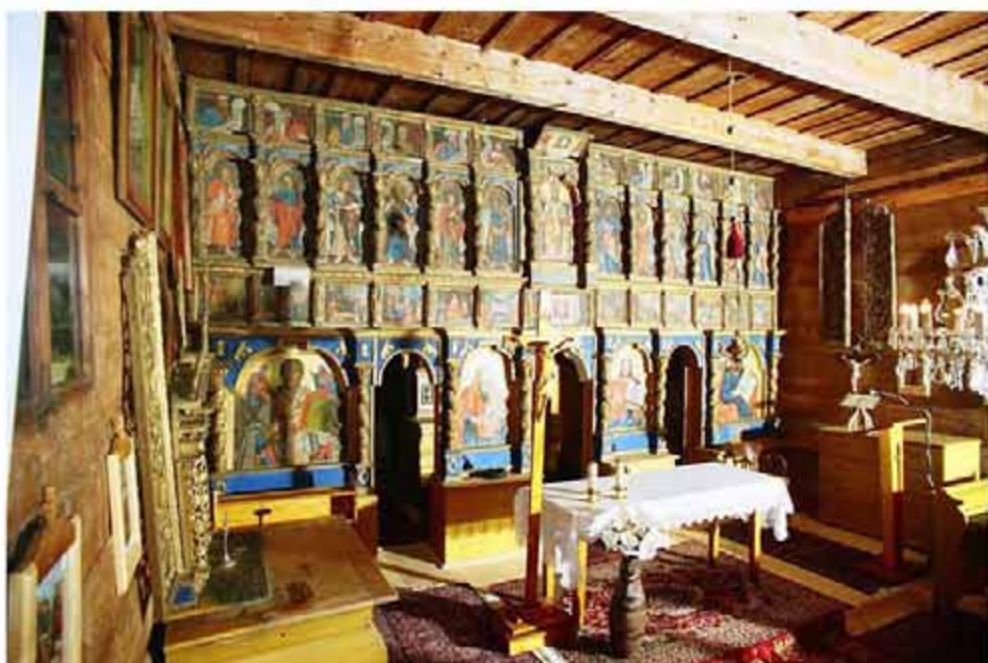
4

Condition: Log construction is quite damaged. Log corner notching are weakened and there is presence of woodworms. Soil that was used to fill the holes between beams is falling down. Roofing is getting damaged as well. The construction of tower needs conservation. All the parts of mobilier are in a very bad condition, namely iconostasis, altar and zhervennik, due to the woodworms and also its construction, wood carving and art decoration are damaged.

Suggested measures: Damaged parts of the log could be repaired by carpenter and then chemically treated and holes could be filled with new soil. Damaged shingles could be replaced. Condition of frame, construction of the tower needs to be examined and repaired. Complex restoration of mobilier should be prepared. Secure the function of security systems.

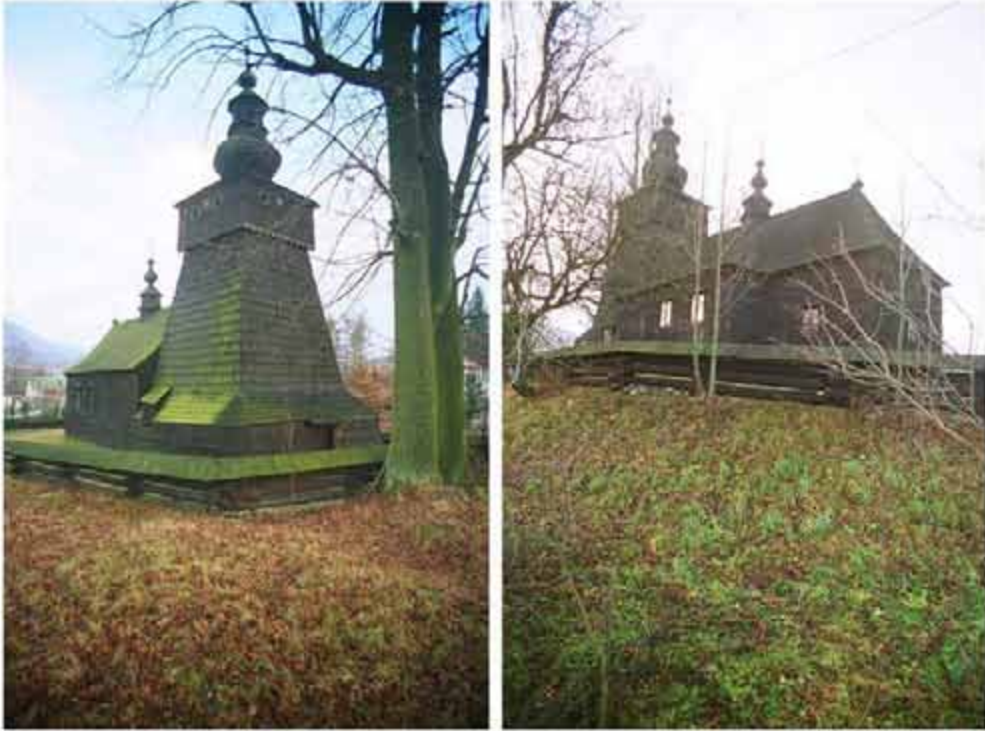
1,2

Condition: The church was restored the last time in 1995. Shingle roofing and planking are partially damaged and are covered with moss on the west. Woodworms are present in the interior as well as on the walls, construction of the iconostasis and benches.

Suggested measures: Shingle roofing should be replaced in the near future and conservation of damaged interior log, iconostasis and benches should be made. Store rooms at the sides of women's room should be cleaned. Enclosure should be maintained as well.

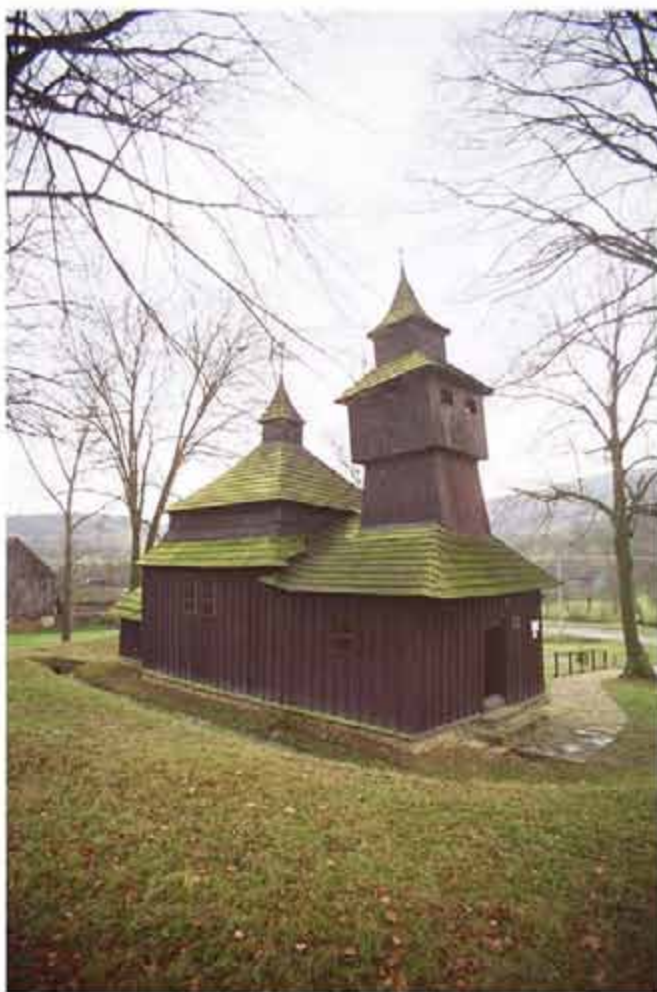
1

Condition: Facing and log walls including the post construction show a certain extent of damage caused by wood worms. There is a danger of leaking because of the ruined shingle roofing. Further, the roof is covered with moss. Thick tops of trees above the church assist the high dampness of the roofing. The interior, the wall paintings of which were renovated more than 30 years ago, is in a quite good condition. Certain damage can be observed only on the iconostasis and some icons.

Suggested measures: It is necessary to replace the shingle roofing and see to the worms-ridden wooden elements in the interests of the interior decoration protection. The icons and iconostasis will need restoration. Attention should be paid to trimming the tops of trees near the church.

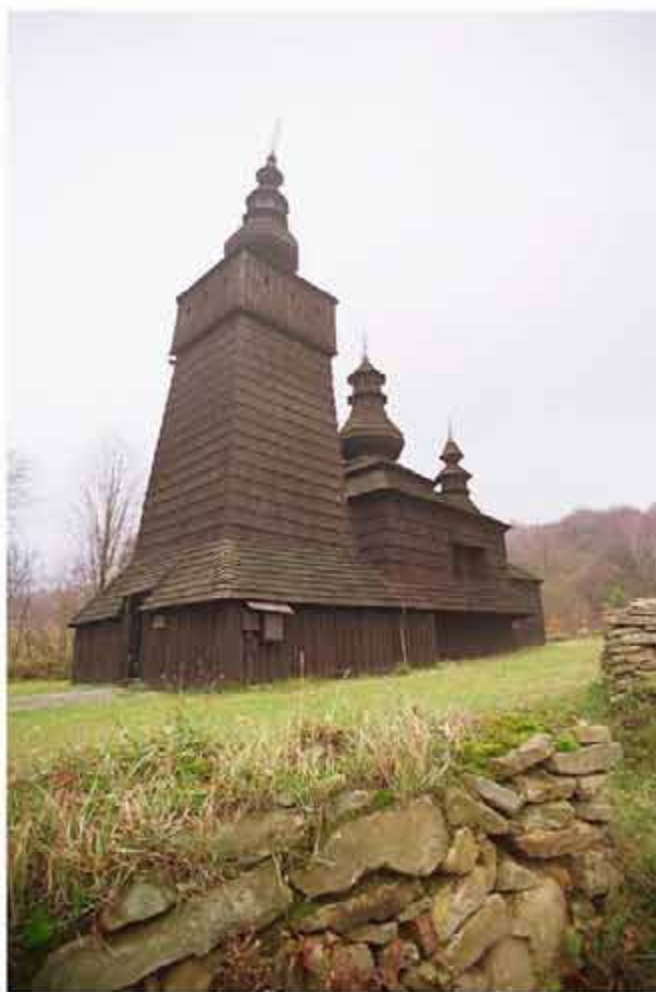
1

Condition: Log of the church, its planking and shingle covering are damaged. There are woodworms active in the log and planking and shingles are covered with moss which will result in roof leaking in near future and it may damage roof contraction. The walls are with preserved paintings. Iconostasis is in extremely bad condition. Altar and zhervennik were renewed. Construction of the belfry and its planking is in the same condition. Entrance of the gate and compactness of masonry are extremely damaged.

Suggested measures: In a short time shingle must be removed, wood must be chemically treated or in some parts the wood or planking replaced. The frame contraction must be treated in the same way. The same work must be done in the tower. Iconostasis must be urgently restored. Stone base wall needs new masonry. Stone fencing needs to be renewed and restored to its original look. Entrance gate needs to be rebuilt.
