# **GREEK CATHOLIC WOODEN CHURCHES IN SLOVAKIA**

Assessment of construction and technical condition of the buildings  
and mobiliar

**Prepared by: Ing. Arch. Ivan Gojdic**  
**In co-operation with: Ing. Arch. Dusan Ferianc**  
**Photographs by: Juraj Mueller**

**Faculty of Philosophy and Arts**  
**Trnava University**  
**2009**

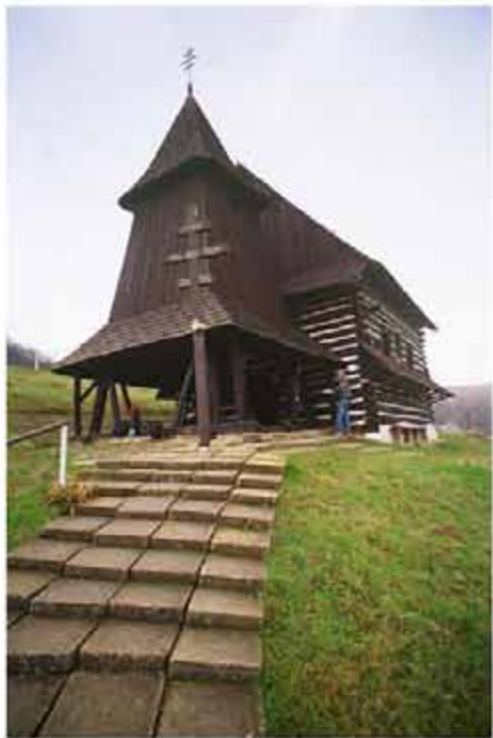
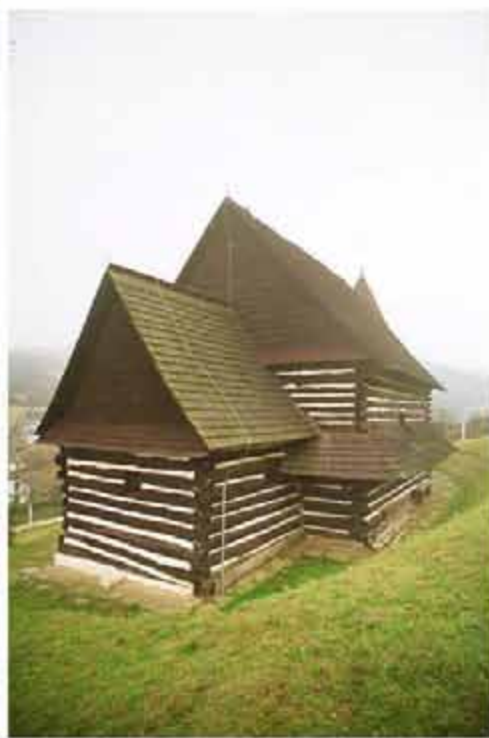
1,3

Condition: Log construction is quite damaged. Log corner notching are weakened and there is presence of woodworms. Soil that was used to fill the holes between beams is falling down. Roofing is getting damaged as well. The construction of tower needs conservation. All the parts of mobilier are in a very bad condition, namely iconostasis, altar and zhervennik, due to the woodworms and also its construction, wood carving and art decoration are damaged.

1. access to the church
2. view of the church from the north
3. view of the church from the east
4. iconostasis

Suggested measures: Damaged parts of the log could be repaired by carpenter and then chemically treated and holes could be filled with new soil. Damaged shingles could be replaced. Condition of frame, construction of the tower needs to be examined and repaired. Complex restoration of mobilier should be prepared. Secure the function of security systems.

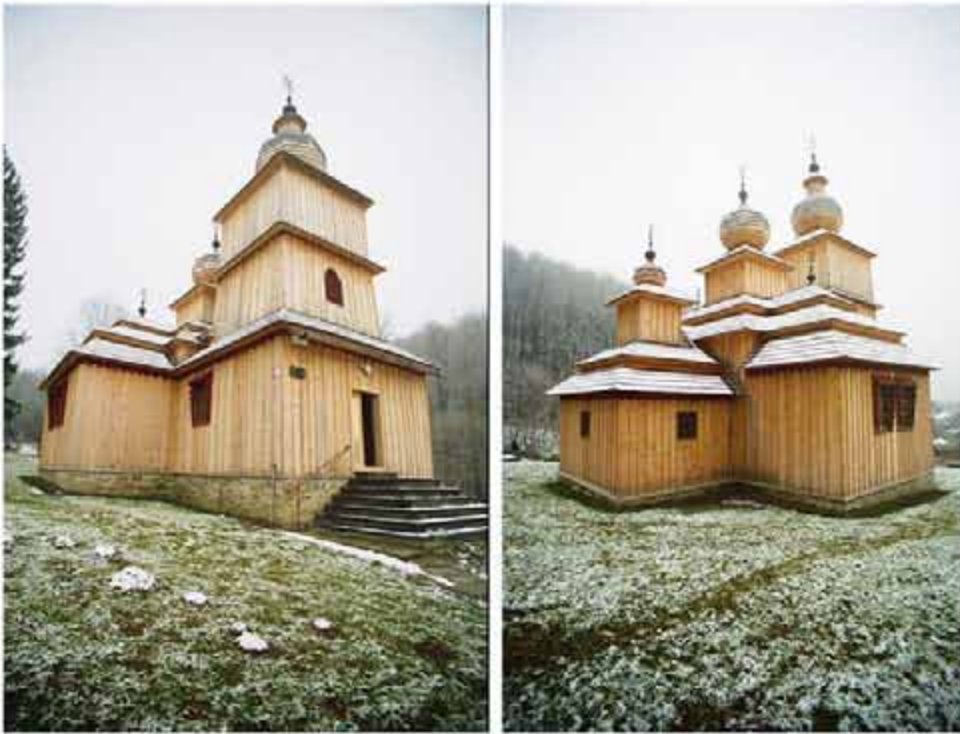
1,2

Condition: The church was badly damaged at the end of Second World War and it was being renewed until 2001. At that time log construction planking, shingle roofing was replaced and stone base wall was reconstructed. As a proof of war there can be still found holes from shots on the boards. Out of the mobiliar only the painting of The Last Judgement has been restored. Other elements are extremely damaged.

1. view of the church from the south-east
2. view of the church from the east
3. view of the church from the west
4. iconostasis
5. altar
6. zhertvennik

Suggested measures: Mobiliar should be restored and replace the present one. Inappropriate fence should be replaced by an aesthetically better one.

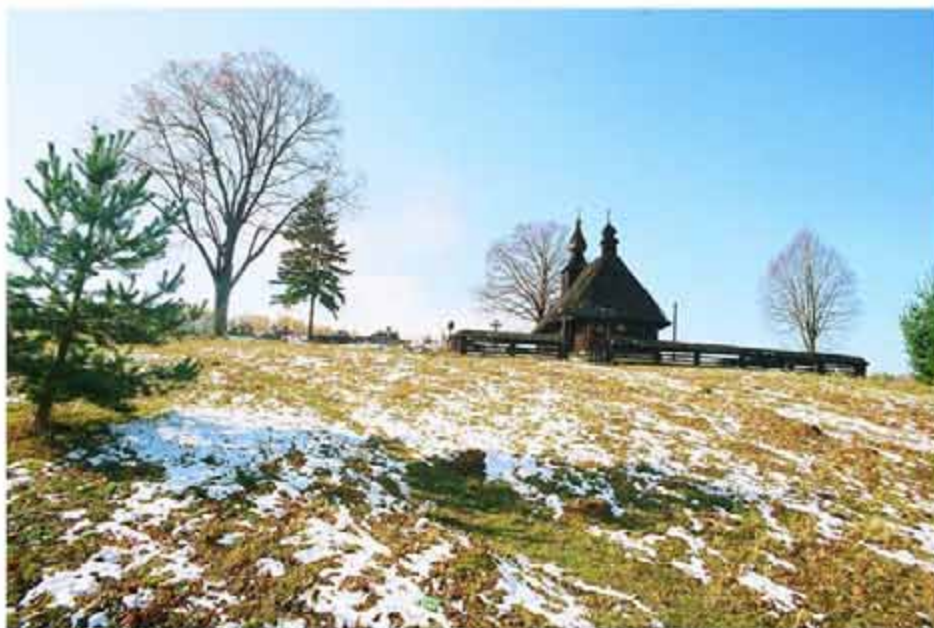
1

Condition: The building is in relatively good condition. Only the shingle is a little bit damaged and there is moss appearing. Mobiliar and the interior of the church are in a good condition.

1. church with the landscape background
2. surrounding of the church from the east
3. surrounding of the church from the west
4. view of the nave
5. iconostasis and chandelier of the nave
6. altar

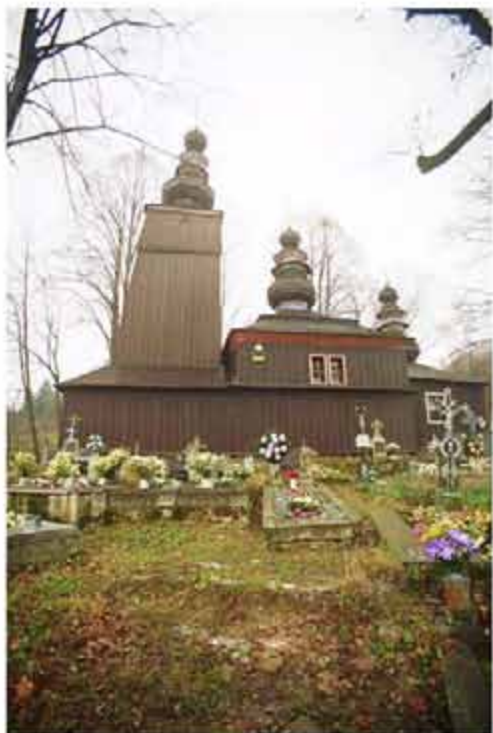
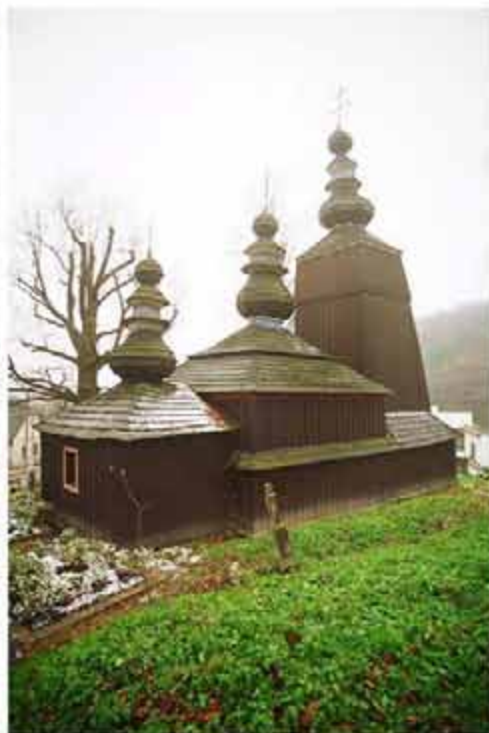
1,2

Condition: Restoration of the interior without the mobiliar, has not been completed yet. The exterior has been reconstructed and we can state that at the moment it is in good condition unless the object is restored to life. In that case there is a danger of devastation.

- 1/ view on the church from the south
- 2/ view on the church from the north
- 3/ view on the church from the east

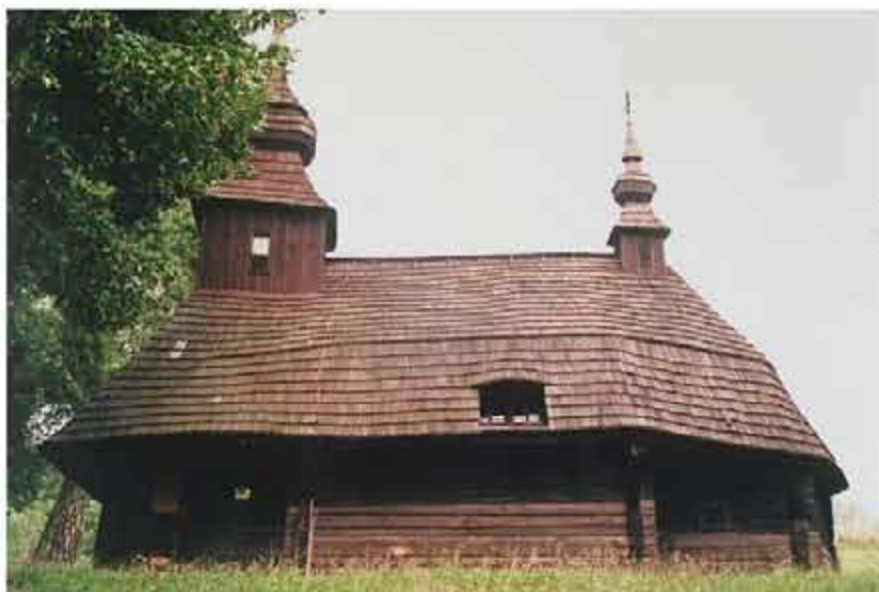
1

Condition: The church was partially restored in the 90s of the 20<sup>th</sup> century. During the renovation the damaged lowest beams of the log building were replaced. Also the shingles on the roof were replaced. It was seen also to the church interior, so its condition can be evaluated positively, despite of the fact that wood worm was not liquidated completely. Iconostasis, its construction and as well as separate icons need some treatment. While the altar is in a convenient condition, the zhertvennik (sacrificial desk) is damaged and renovation is inevitable. The bell-tower is in a good condition.

- 1/ view on the church from the south
- 2/ view on the church from the north
- 3/ view on the church from the north-east
- 4/ iconostasis
- 5/ altar
- 6/ zhertvennik

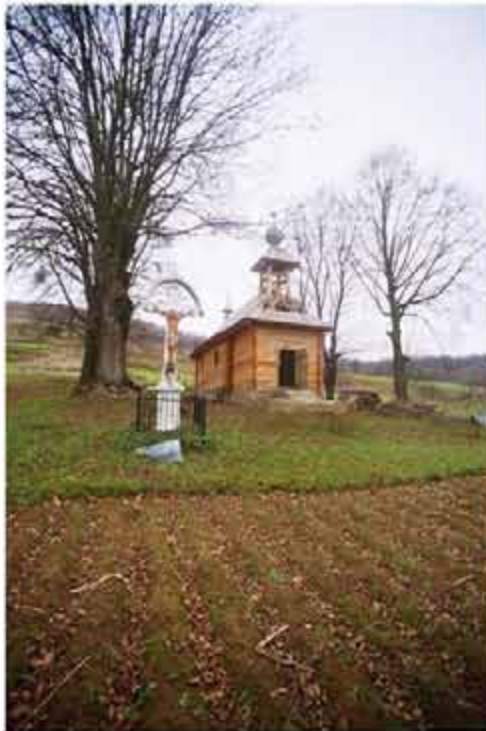
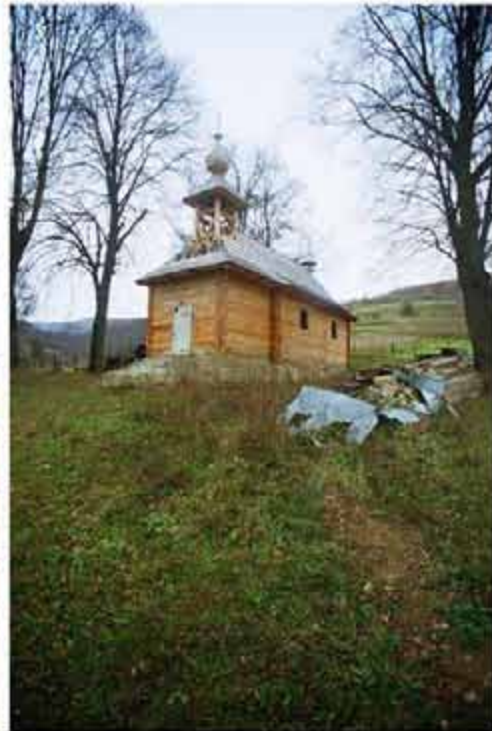
1,2

Condition: The church was taken to bits and replaced by a copy in the same material. As there were some arguments between the investor and the sights institution during the reconstruction, the work was stopped before completion. Currently, there are only peripheral walls and truss construction including the roofing.

- 1/ placement of the church above the village
- 2/ view on the church from the west
- 3/ view from the unfinished church

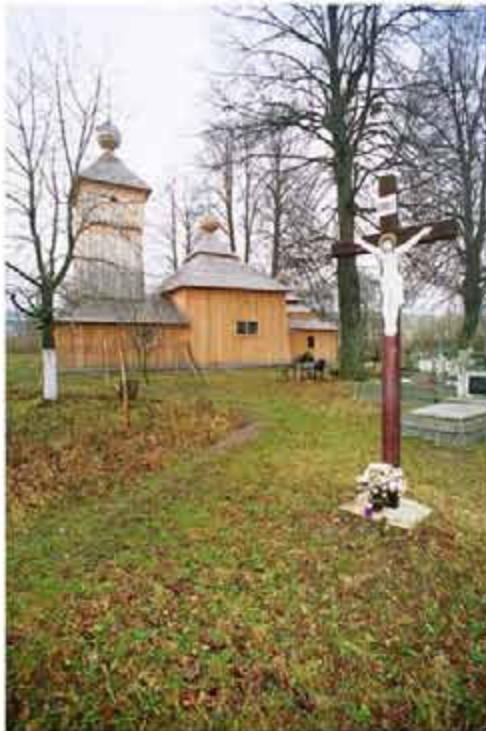
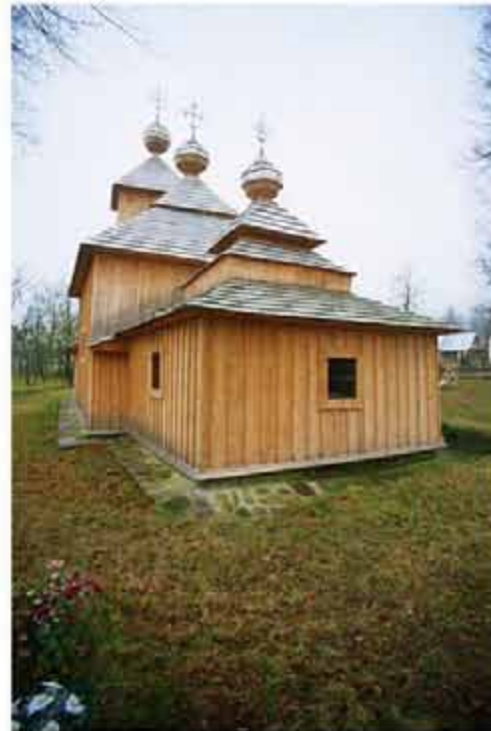
1,2

**Condition:** In 2001 and 2002 the church was completely reconstructed, including the static failures on southern wall of the nave and the vaulted ceiling of the sanctuary near the iconostasis. Mains and security equipment were replaced and completed. The recently restored iconostasis, seriously jeopardized by static failures, was dismantled and re-treated. The fence was not restored nor the access road which is sometimes flooded with water.

- 1/ view on the church from the south
- 2/ view on the church from the east
- 3/ the entrance door to the hall
- 4/ the iconostasis
- 5/ the vaulted ceiling in the nave
- 6/ view on "empora"
- 7/ altar
- 8/ the icon of the Mother of God

**Suggested measures:** As the building is in good condition at the present, it is necessary to pay attention to cultivation of its surroundings, to replace the fence and to make the road firmer.

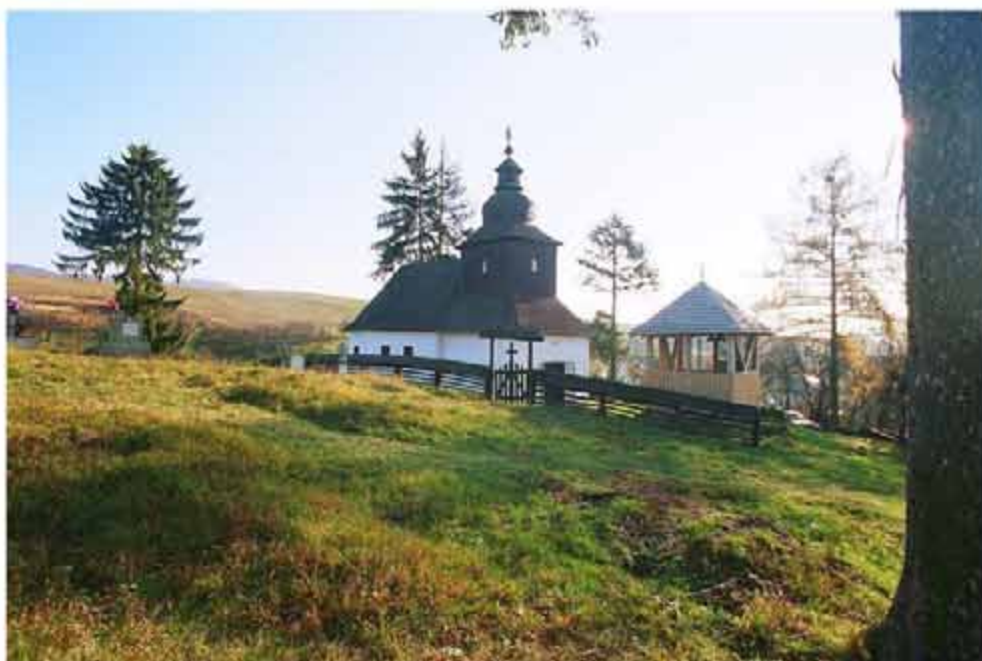
1

Condition: The mud coat has recently been restored from both inside and outside. Despite of that, there appear spots caused by the damp parts of the log building. Shingle roofing is damaged very much and there is a danger of leaking. The interior is in good condition, as well as the restored iconostasis, altar and zhertvennik.

The bell-tower is in good condition, but the fence with gates shows a local damage of shingles and beams.

Suggested measures: To replace the damp plaster. To check the roofing, complete it locally or replace it by new roofing. The tower building and truss will need some attention during the roofing replacement. The fence enclosing the church area will have to be treated.

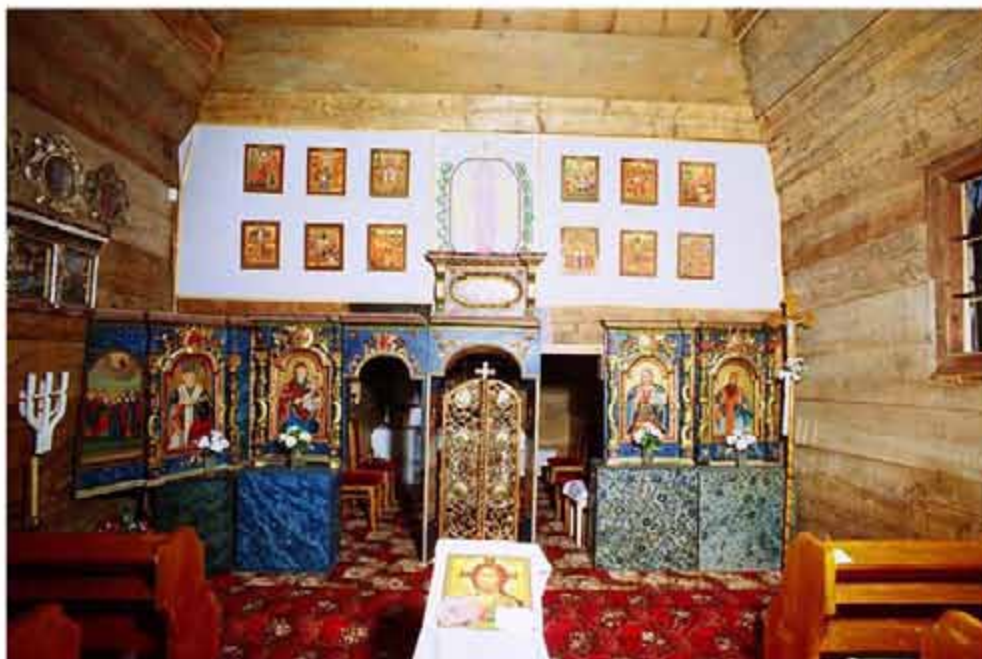
4

Condition: The church was reconstructed in 2001 and 2002. During the restoration, the plaster and shingle roofing were replaced. Restoration of the furnishings began, but is not completed yet. Condition of the church and the entrance gate is good. The fence around the church will demand for some preservation work.

Suggested measures: First of all, it is necessary to complete the restoration of the iconostasis construction. The slightly damaged fence will need some preservation. The access road is, due to rain, often washed away and will have to be made firmer in compliance with the wooden architecture.

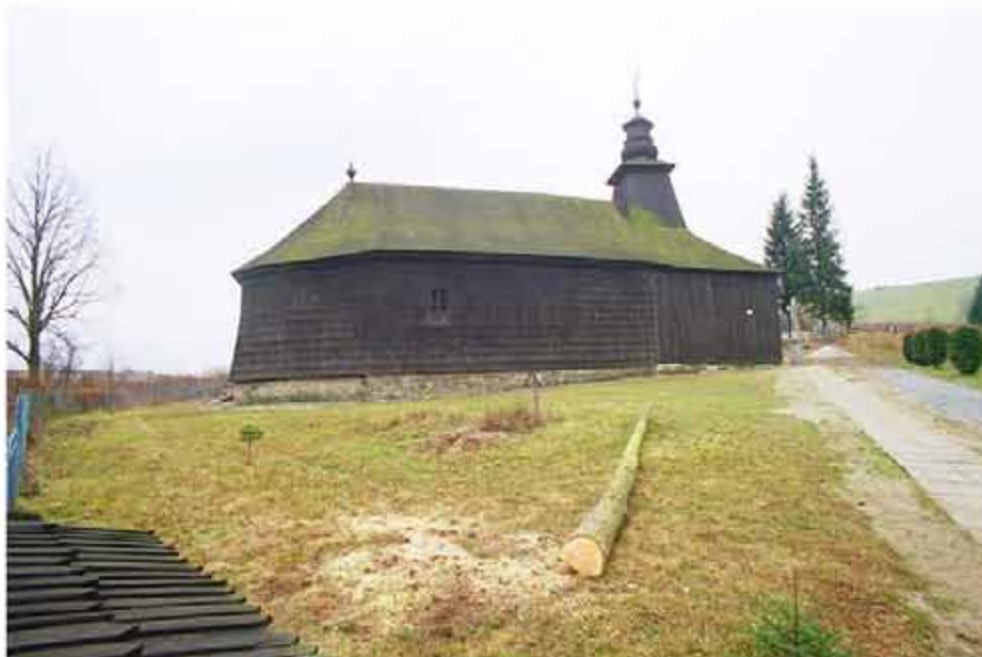
1

Condition/State: While the log has been infected by wood damaging insects merely partly, shingling and panelling are explicitly passing away. There is a threat of continuous leaking. Unique icons from 16<sup>th</sup> and 17<sup>th</sup> centuries situated on the nave walls are damaged as well. Non-esthetical fencing is out of order, entrance communication is covered by water running from the cemetery.

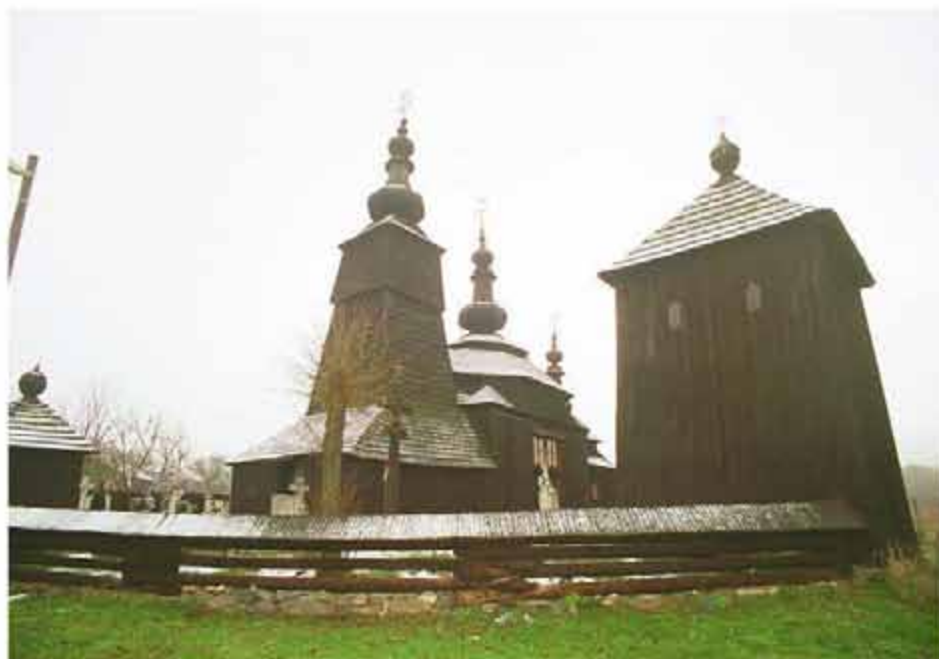
1

Condition: The log construction, tower pillars and belfry are infected by wood damaging insects. Shingled roofing is continuously passing away and soon leaking is probable. Planked packing is bad letting snow and rain run through the backdoor. Nets are gone. Iconostasis has been restored and is now in a good condition. Re-activity of wood damaging insects cannot be excluded. Wooden fence and gate suffer from the weather changes.

Suggested measures: In close future complete and change the shingled roof over the whole area. Locally fix the church planking. Fix the nets and signal system. Examine the iconostasis condition and slowly end up free icons restoration.

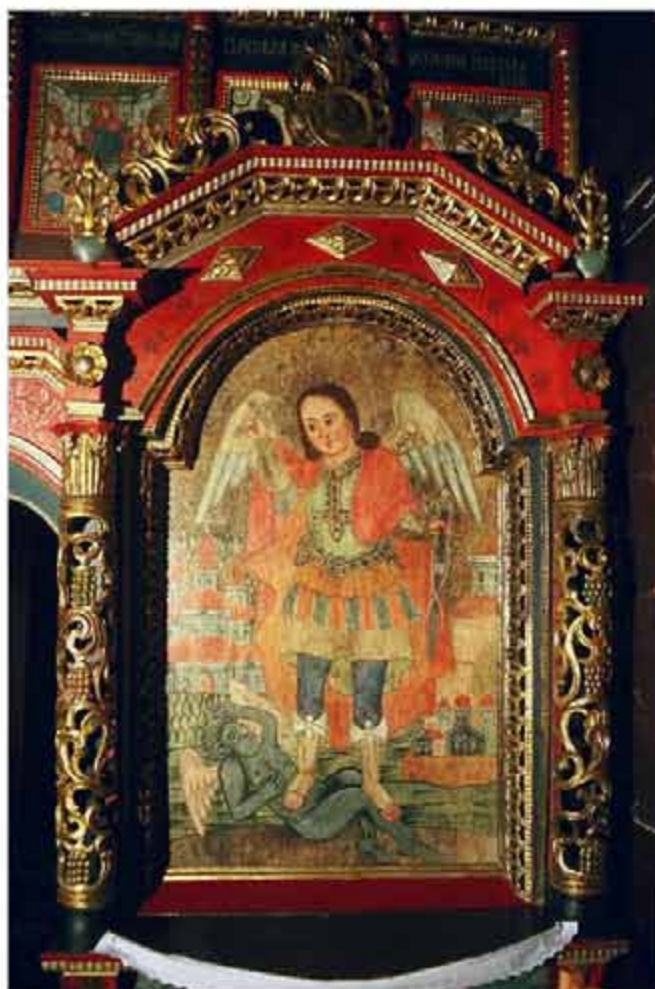
3

Interior is characteristic for its Baroque features. Iconostasis was damaged by the 20<sup>th</sup> century fire. Icons on the wall come from the same period.

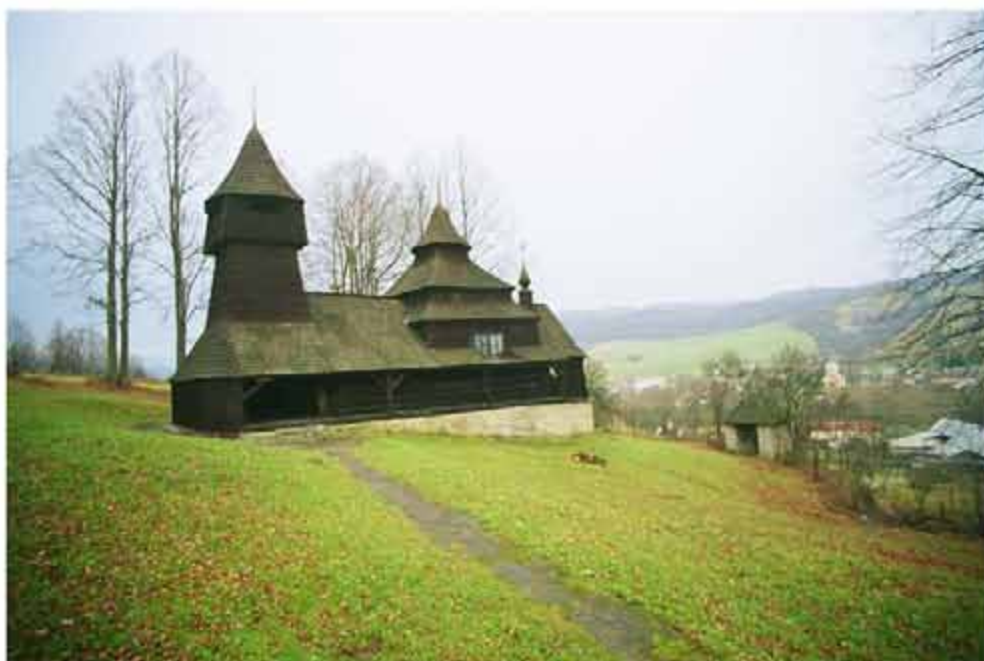
1

Condition: Re-appearing of wood damaging insects represents the most serious problem. Such a spread might cause the church destruction. Wooden substance of the log and the movables are also in a bad condition, infected in a same way. The nave window packing is getting worse, in some parts even planking leaking is visible. Cracks on a frame construction of the tower are the problem as well. Shingle is moss-grown and soon raining water may be leaking. Iconostasis as well as individual icons are in a very bad state, paintings are falling apart, wood-carving decoration is cracking.

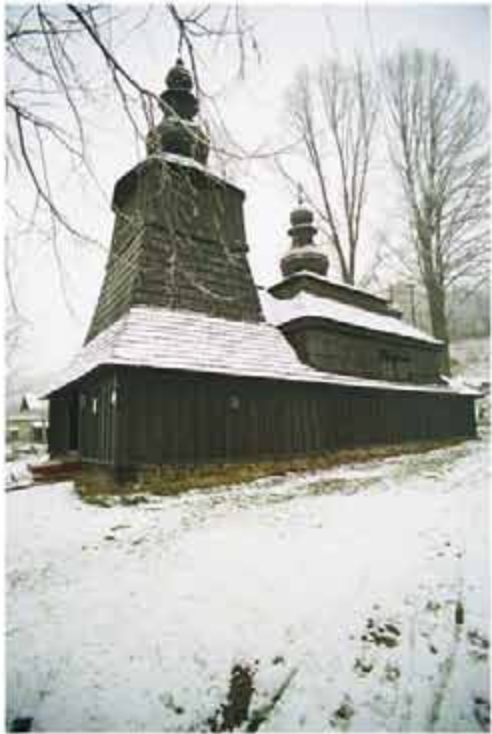
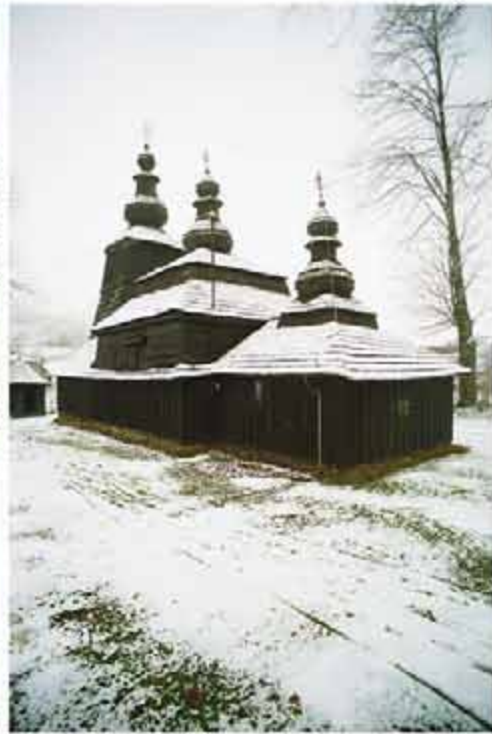
1,2

Condition: The log construction is damaged, active wood damaging insects is present.

- 1/ view of the church from the east
- 2/ view of the church from the west
- 3/ iconostasis
- 4/ altar
- 5/ free icon – The Mother of God's Death
- 6/ zhertvennik

Suggested measures: Detailed analysis of the log construction, partly change or fix damaged beams. The same should be done with the tower. Complete wainscoting and get ready for shingle change. Fix the floors. Wooden construction with active wooden damaging insects presence should be treated chemically. Prepare consecutive icons treatment by restoration.

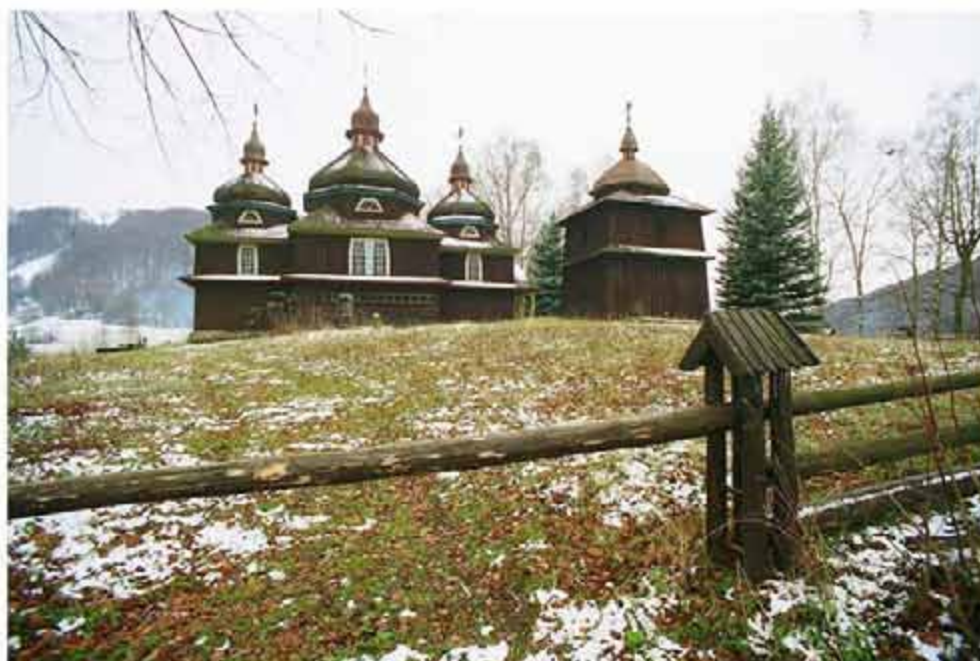
1

Condition: Woodworms are active in interior and exterior. Planking and shingle roof is too old and about to start to leak in near future. There were signs of leaks in the past in the interior. Belfry is in the same condition. Fence is absolutely inappropriate from the point of architecture of the church.

1. Church
2. view of the church from the west
3. view of the church from the east
4. icononostasis
5. belfry
6. altar

Suggested measures: Renew stone base wall of the church. Repair the damaged parts of the log planking and shingle roof. Wood of the building and mobiliar must be chemically treated. Renew colour of the original paint. Mobiliar and iconostasis must be cleaned and conserved. More aesthetical fencing should be put or it could be left without any fencing.

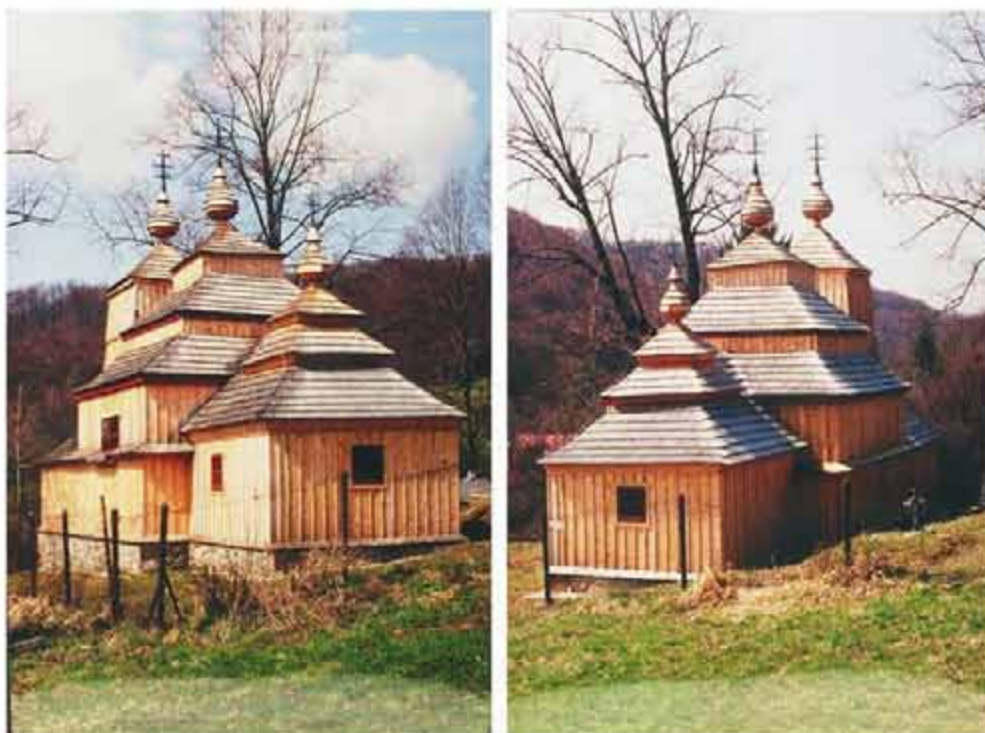
1, 2

Condition: The church was restored in 2001-02. Building case and its covering were changed. At the same time the log beams and spire construction were conserved. Nevertheless wood damaging insects has reactivated in some parts of the nave. Iconostasis and the sanctuary movables have been mended and thus they are in a good condition. Fencing and entrance communication have not been fixed and are in a bad condition.

- 1/ view of the church from the south-east
- 2/ view of the church from the north-east
- 3/ view of the church from the north
- 4/ iconostasis
- 5/ altar
- 6/ zhertvennik

Suggested measures: Examine wood damaging insects occurrence, treat damaged parts chemically. Change the existing fence by the more aesthetical one and fix the entrance communication.

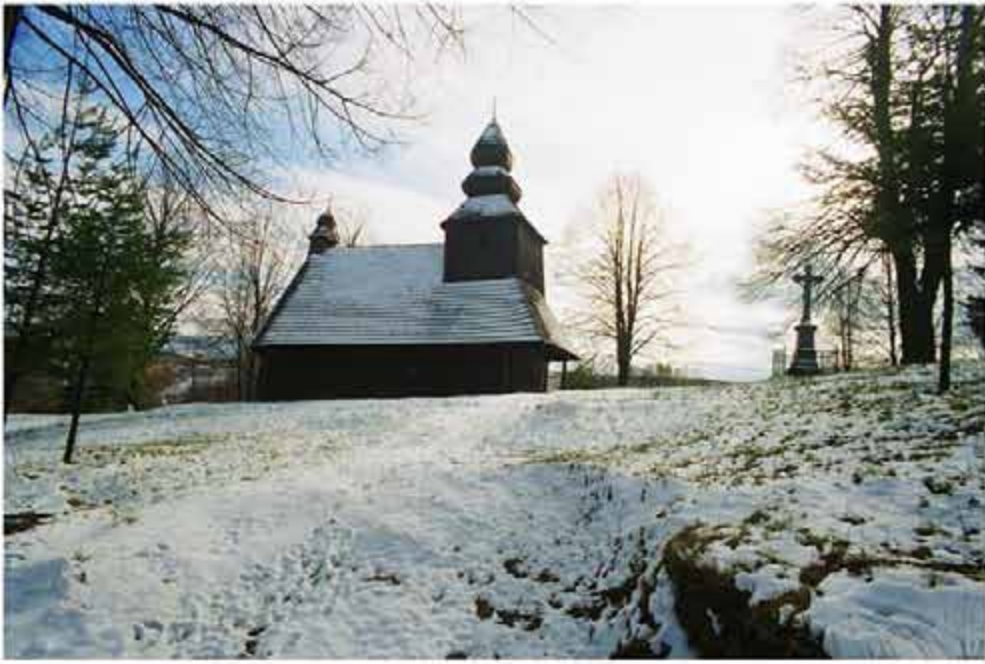
1

Condition: The church itself is in a quite good condition. Wood damaging insects appears locally, especially within the tower and roof construction. Shingle covering has been changed, considerable damages are not visible. The movables were restored at the beginning of 90s of the 20<sup>th</sup> century.

- 1/ view of the church on the hill
- 2/ view of the church from the south
- 3/ view from the west
- 4/ view of the nave and iconostasis
- 5/ altar
- 6/ zhertvennik

Suggested measures: Parts infected by wood damaging insects should be treated chemically.  
Watch the condition of covering.

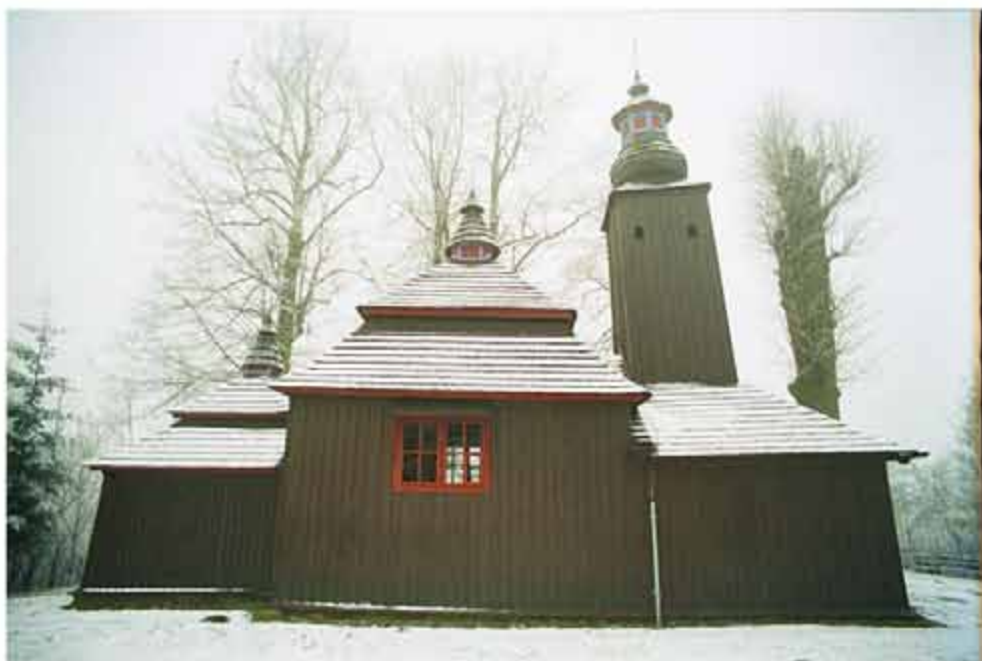
1

Condition: The building has recently been restored. The planking and roofing material have been patched. Traces of wood worms can be found in the log walls and post construction of the nave.

- 1/ view on the church from the north
- 2/ view on the church from the north-west
- 3/ icon of St. Nicolaus and the Mother of God
- 4/ iconostasis
- 5/ altar
- 6/ zhertvennik

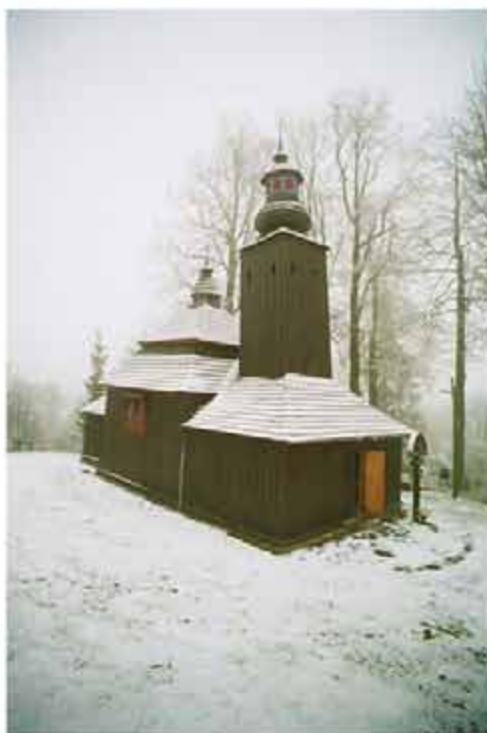
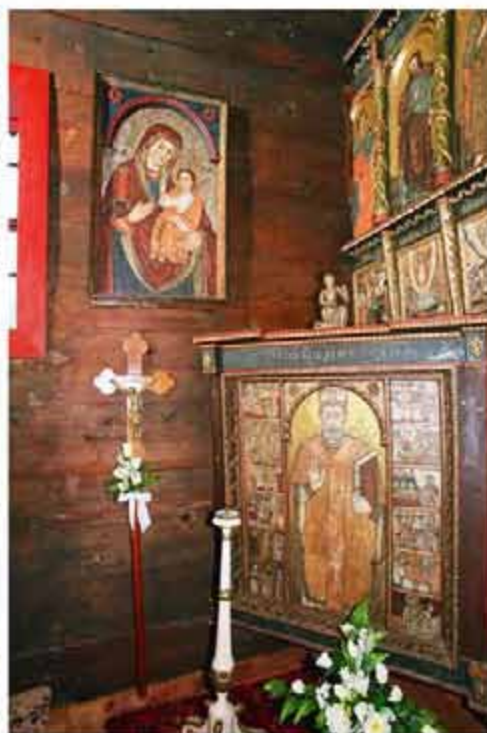
3, 4

The wall paintings and mobiliar are in a very bad condition. Wood worms are in the wood. The paintings are pulverizing and falling off.

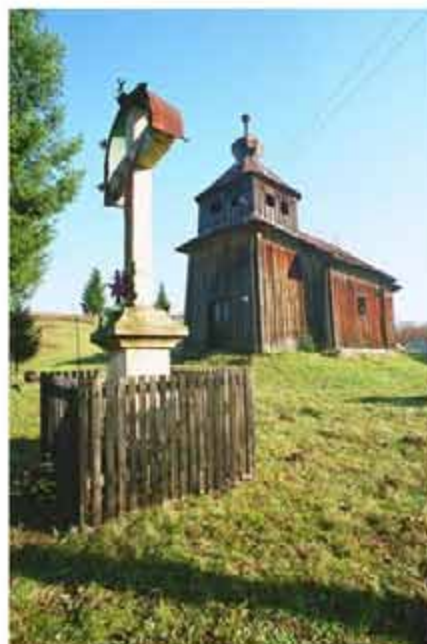
1

Condition: After building a new church this one is rarely used and it is quite damaged.

1. view of the church from the path
2. view of the church from the south
3. view of the church from the north-east
4. iconostasis
5. altar
6. zhervennik

Suggested measures: Roof covering should be replaced with shingle roof. Roof construction should be treated and repaired. The same thing must be done with the log construction of the wall. Wet plaster must be removed from interior and replaced by new ones but only after the wood is dry. The concrete must be removed. After the building construction has been treated mobiliar can be restored and surrounding treated.

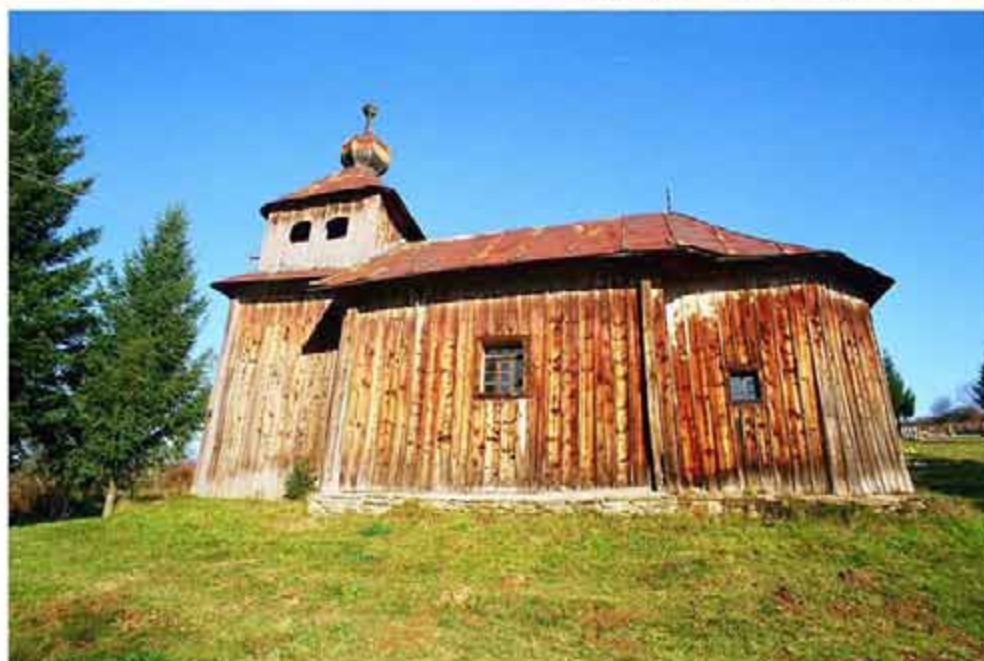
2

Tinplate is already leaking in several places. The worst leaks are on the place where nave joints women's log room. So the interior plaster and log construction are extremely damaged close to the leaks and even there are visible some destructions of the parts of the walls. Woodworms are active. The place around the walls is stuffed up, what causes dampness and crumbling of log construction. The dampness is made worse by concrete floor. The dampness is reflected on the mobiliar, namely paintings and icons are endangered and it helps woodworms to spread. The surrounding of the church is only sporadically taken after. The fence does not exist and the path is damaged by rainwater.

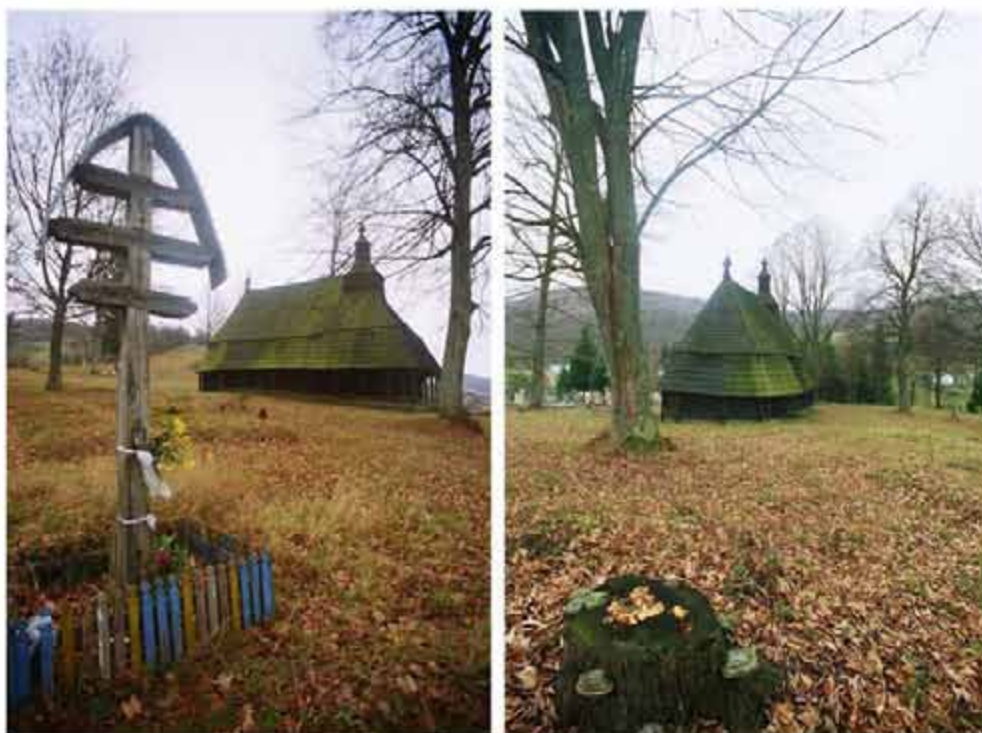
1, 2

Condition: The church is in a very bad condition as a result of being only rarely used due to the building of a new one. Huge roof is supported by temporary pillars - beams which show signs of static and wood harmful insect damage. Roofing is rotting and there is a danger of leaking. Mobiliar has probably never been renewed since its existence except unsuitable repainting. Woodworms are damaging construction of iconostas and altar. The paint is peeling off. The icons that can be found in the nave and some older ones also show signs of damage.

1. view of the church from the west
2. view of the church from the north-east
3. view of the church from the south
4. iconostasis
5. empora
6. zhetrvennik

Suggested measures: Static of the building must be examined and consequently repairs of the log and roof construction could start. Roofing must be removed. Frame construction, which is on the perimeter of the building, must be refined. Wood must be chemically treated. Then altar iconostasis and zhetrvennik can be restored and conserved. Mobiliar and valuable banister is needed to be restored as well. The belfry needs to have roofing replaced and construction must be examined.

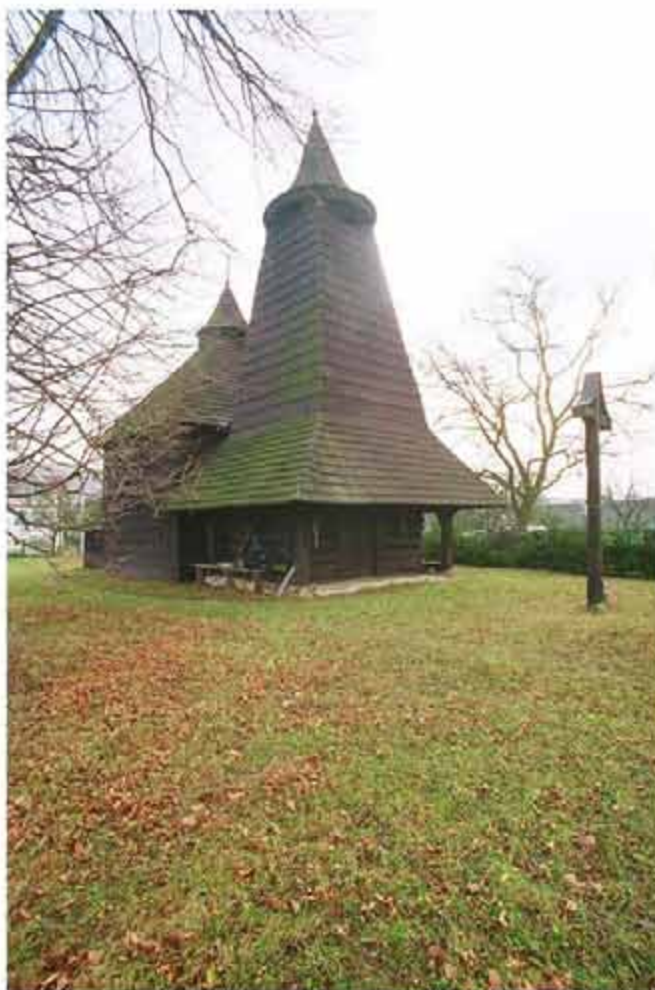
1

**Condition:** The log construction is infected by wood damaging insects, individual beams in the sanctuary room are being destroyed and wetted. Exterior as well as roof shingling is moss-grown even covered by metal; possible destruction is visible. Frame construction is reported similar damages. Wooden floor is also weakened. Nets are in order however revision is needed.

- 1/ view of the church from the south
- 2/ view of the church from the north-east
- 3/ the nave and iconostasis
- 4/ empora and The Last Judgement
- 5/ altar

**Suggested measures:** Locally change damaged parts of the log construction, successively chemically treat the log construction. Complete /but minimum locally/ shingling and planking change. Fix the floor. Examine the nets. Get ready for the movables as well as free icons conservation and restoration.

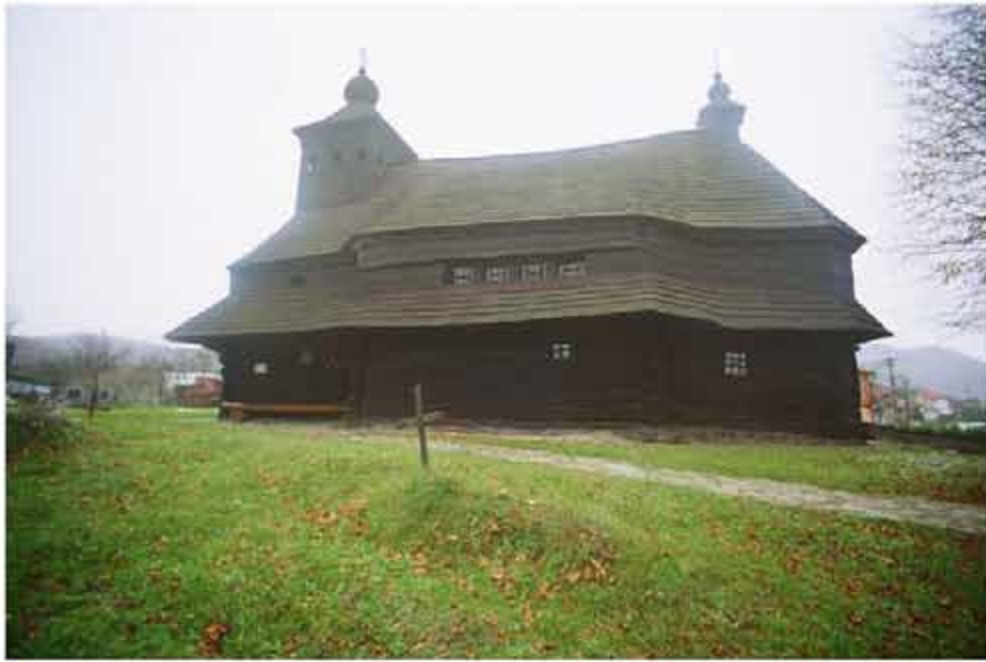
1

**Condition:** The interior and exterior log construction is infected by wood damaging insects which may cause destruction of recently restored movables. Shingles are damaged locally. On the whole one may say interior is kept in order, nets including. Cemetery area is preserved as well. Wooden fence construction is damaged.

- 1/ view of the church from the south
- 2/ view of the church from the west
- 3/ view of the nave northern wall
- 4/ view of the nave iconostasis
- 5/ view of the tower inside
- 6/ altar

**Suggested measures:** The log construction must be chemically treated, frame construction of the tower must be conserved. Examine the shingles and change the wrong ones. Finish the restoration of solitary icons and zhertvennik. Change damaged fence elements and conserve older preserved beams.

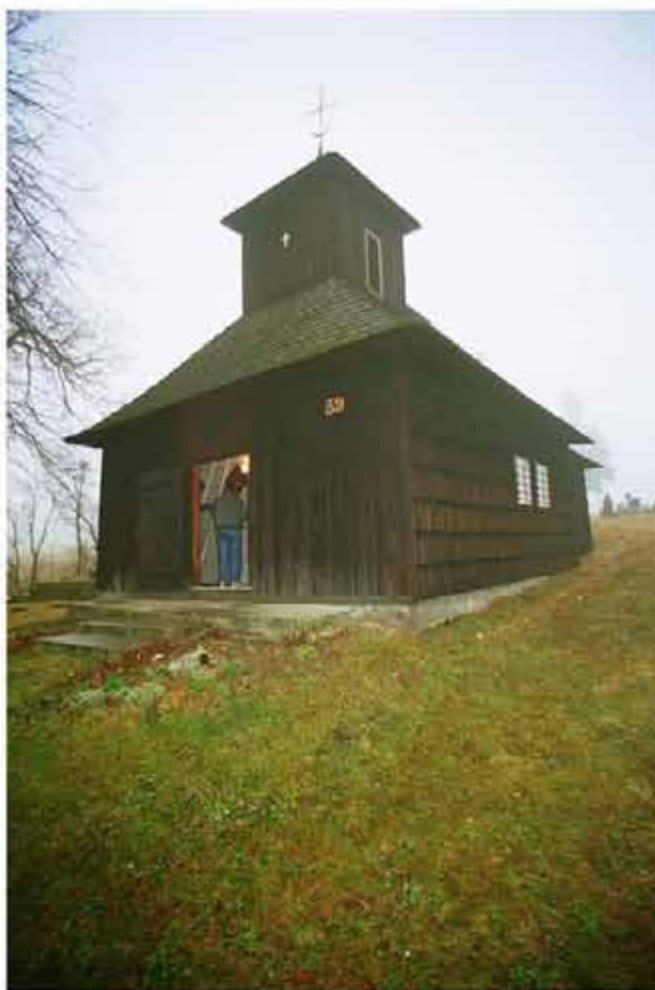
1

- 1/ view of the church from the west
- 2/ view of the church from the north
- 3/ view of the nave iconostasis
- 4/ altar

Suggested measures: Soon change the covering and thus prevent the building from leaking. Damaged parts of the roof construction must be treated locally.

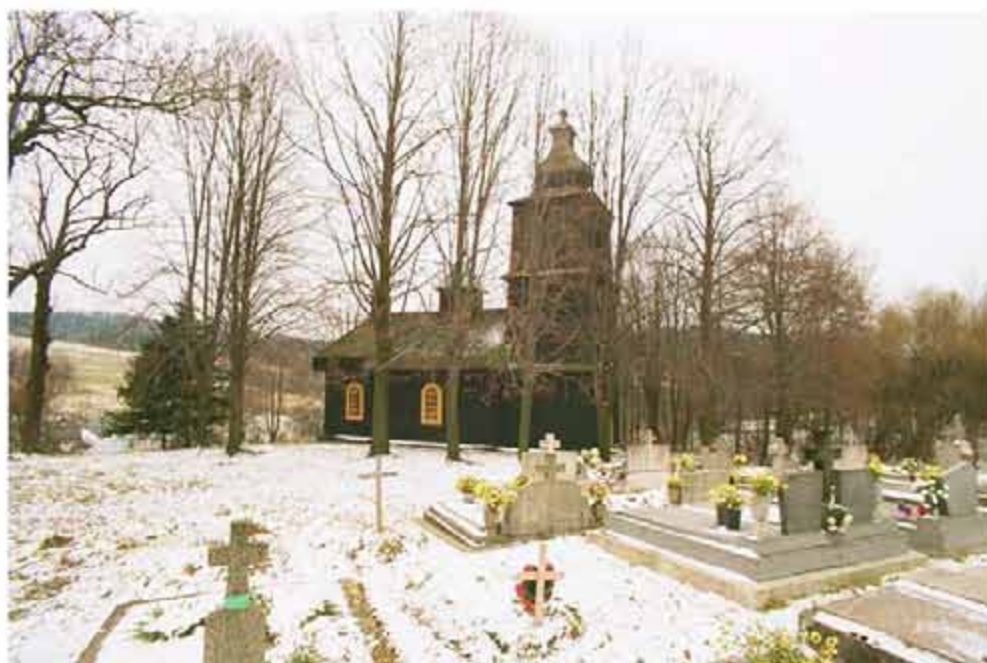
1

Condition: The church is in a quite good condition but mainly the wooden planking of the walls is worm- ridden. First indications of damage can be seen also on the roofing. The mobiliar with the exception of the zhertvennik are in a good condition.

- 1/ view on the church at a cemetery
- 2/ view on the church from the south
- 3/ view on the church from the east
- 4/ iconostasis
- 5/ altar
- 6/ zhertvennik

Suggested measures: It is necessary to treat the places with visible activity of wood worms and to check the condition of the roofing, especially in the places of connection of the roof construction and the tower. The zhertvennik will need restoration. The fence enclosing the church area should be thought over.
